Boardman Wetland Design Project

Cleckamas County Oregon

Wetlands and Waterbodies Delineation Report

Boardman Wetland Design
Clackamas County, Oregon

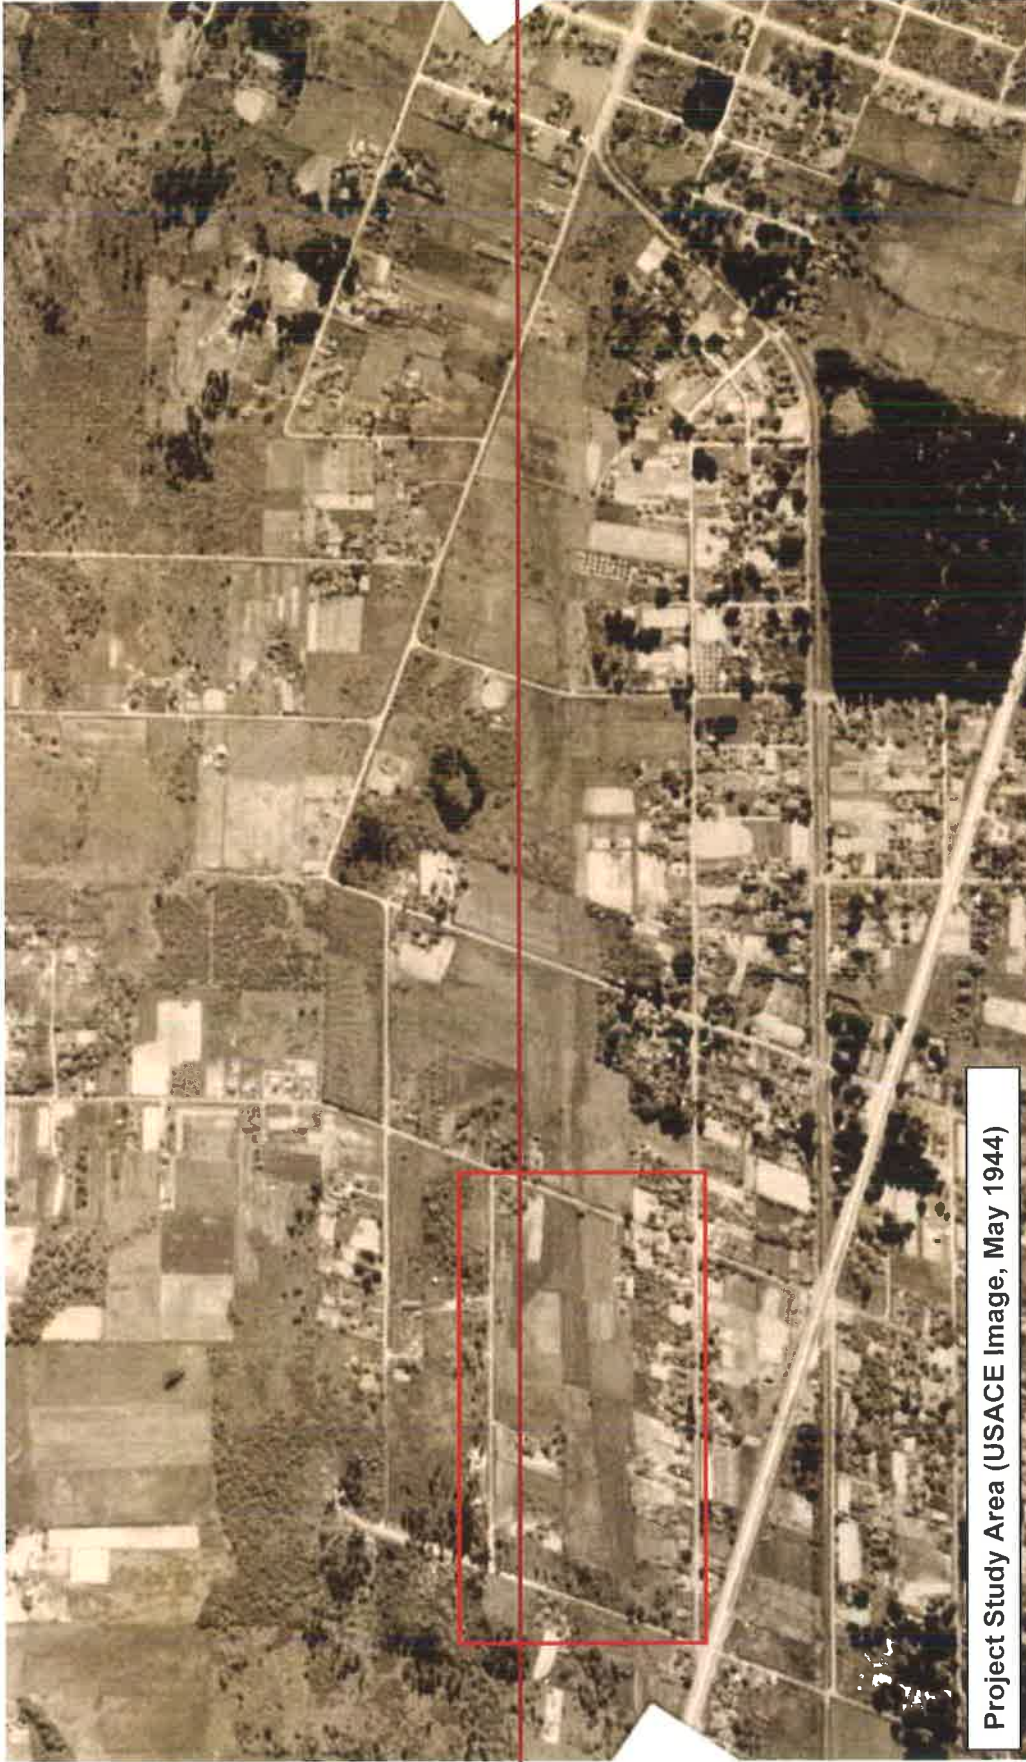
Project Study Area (USACE Image, May 1944)

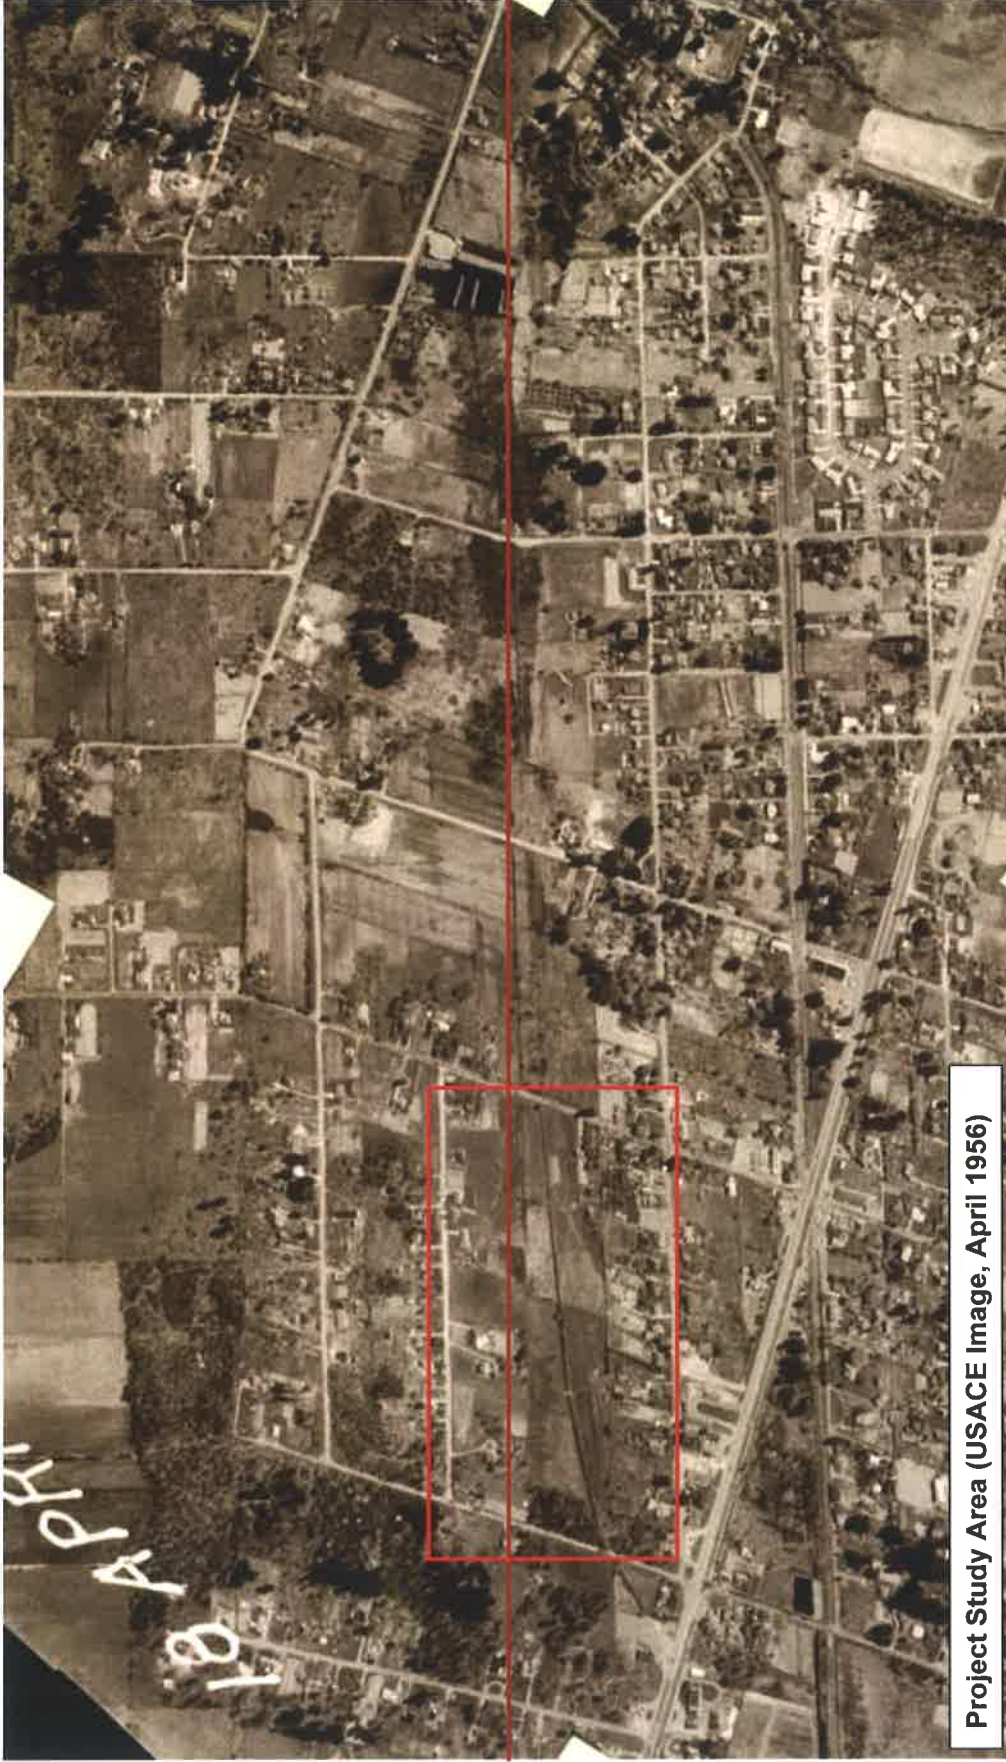
Project Study Area (USACE Image, April 1956)

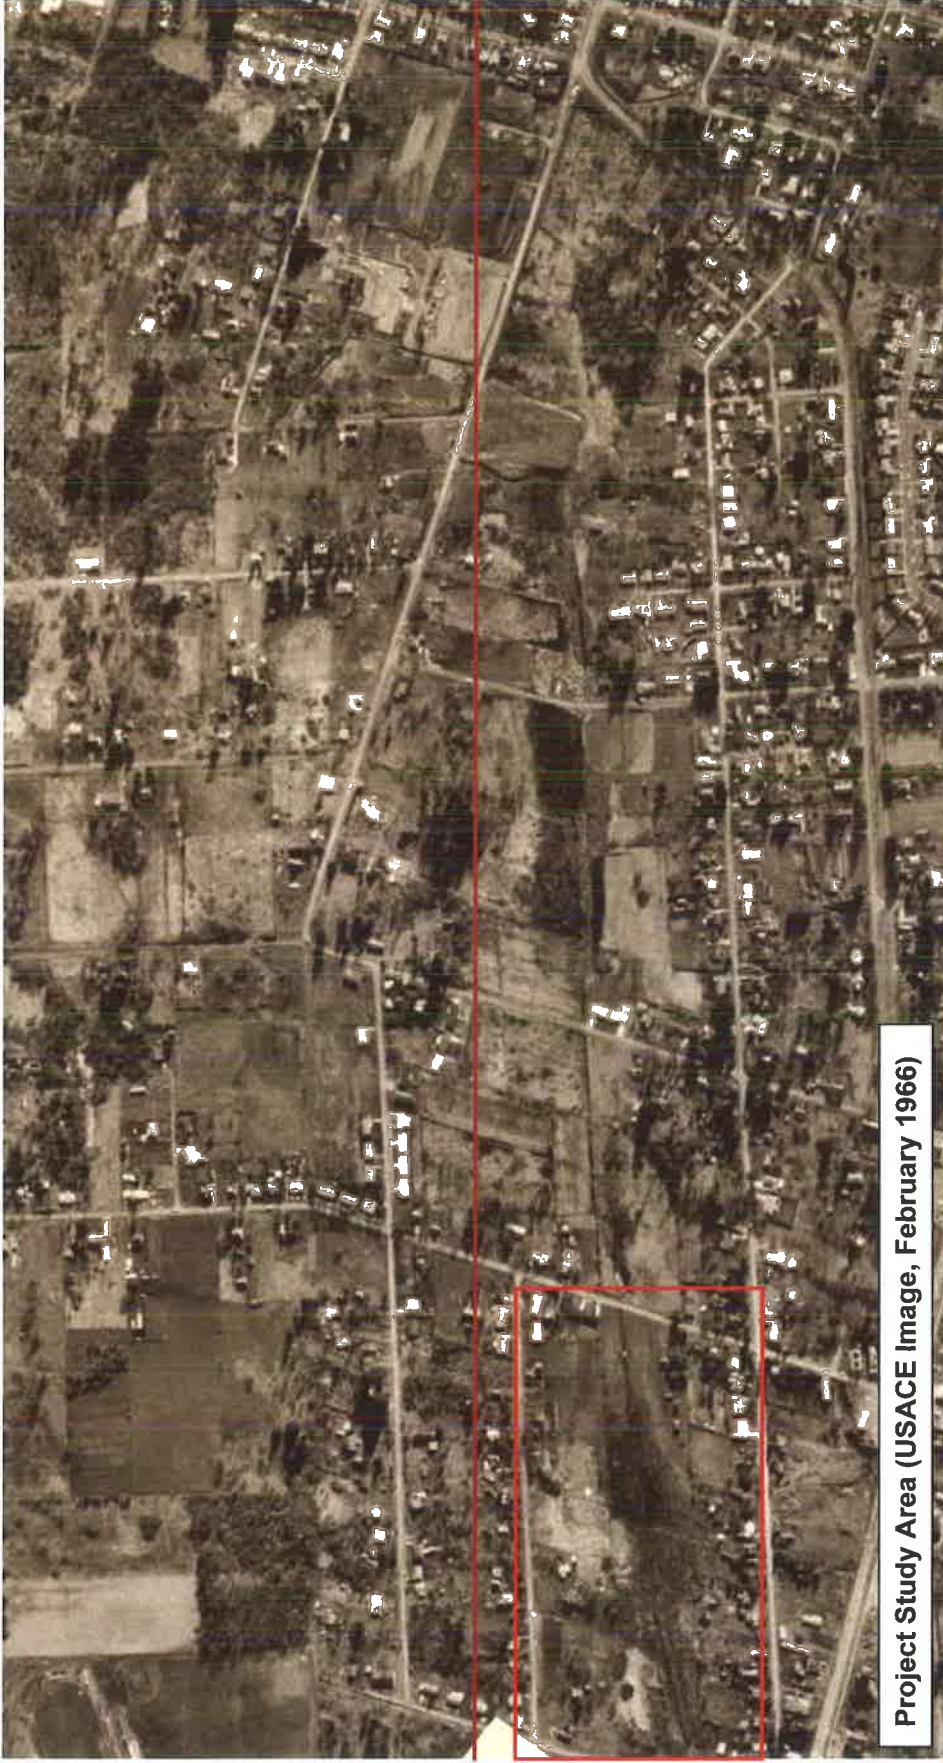
Project Study Area (USACE Image, February 1966)

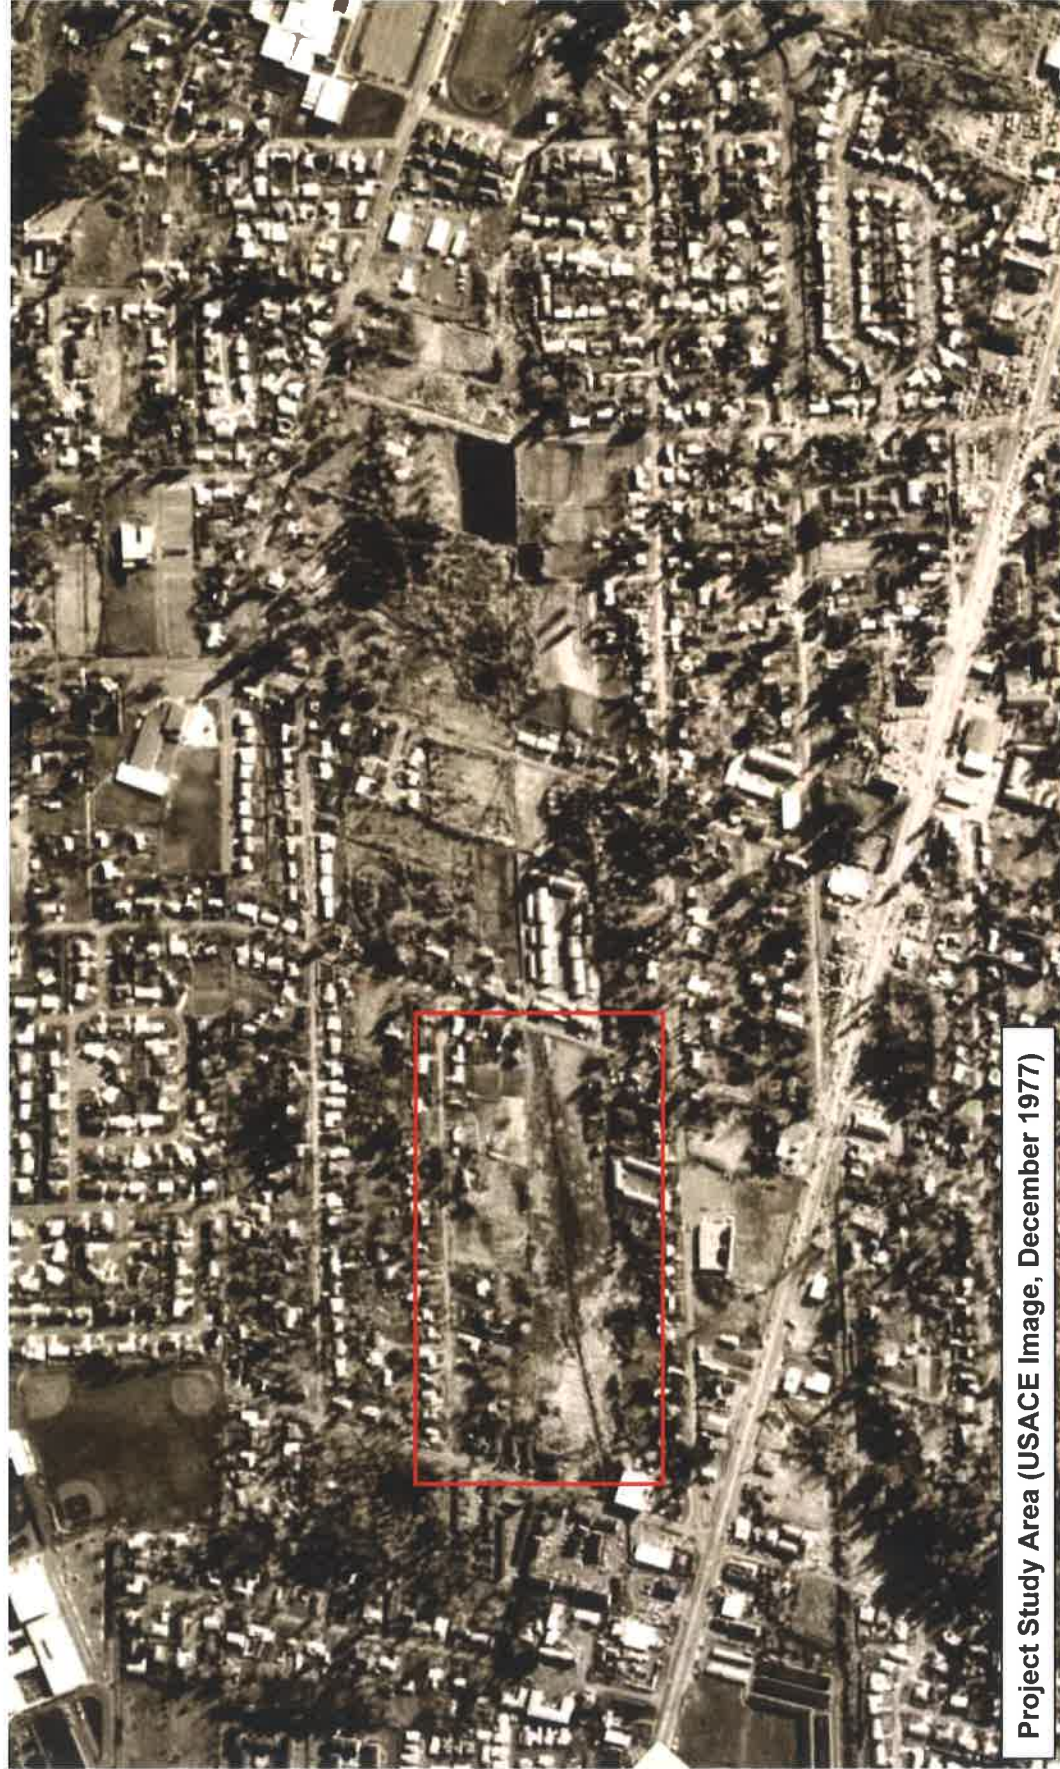
Project Study Area (USACE Image, December 1977)

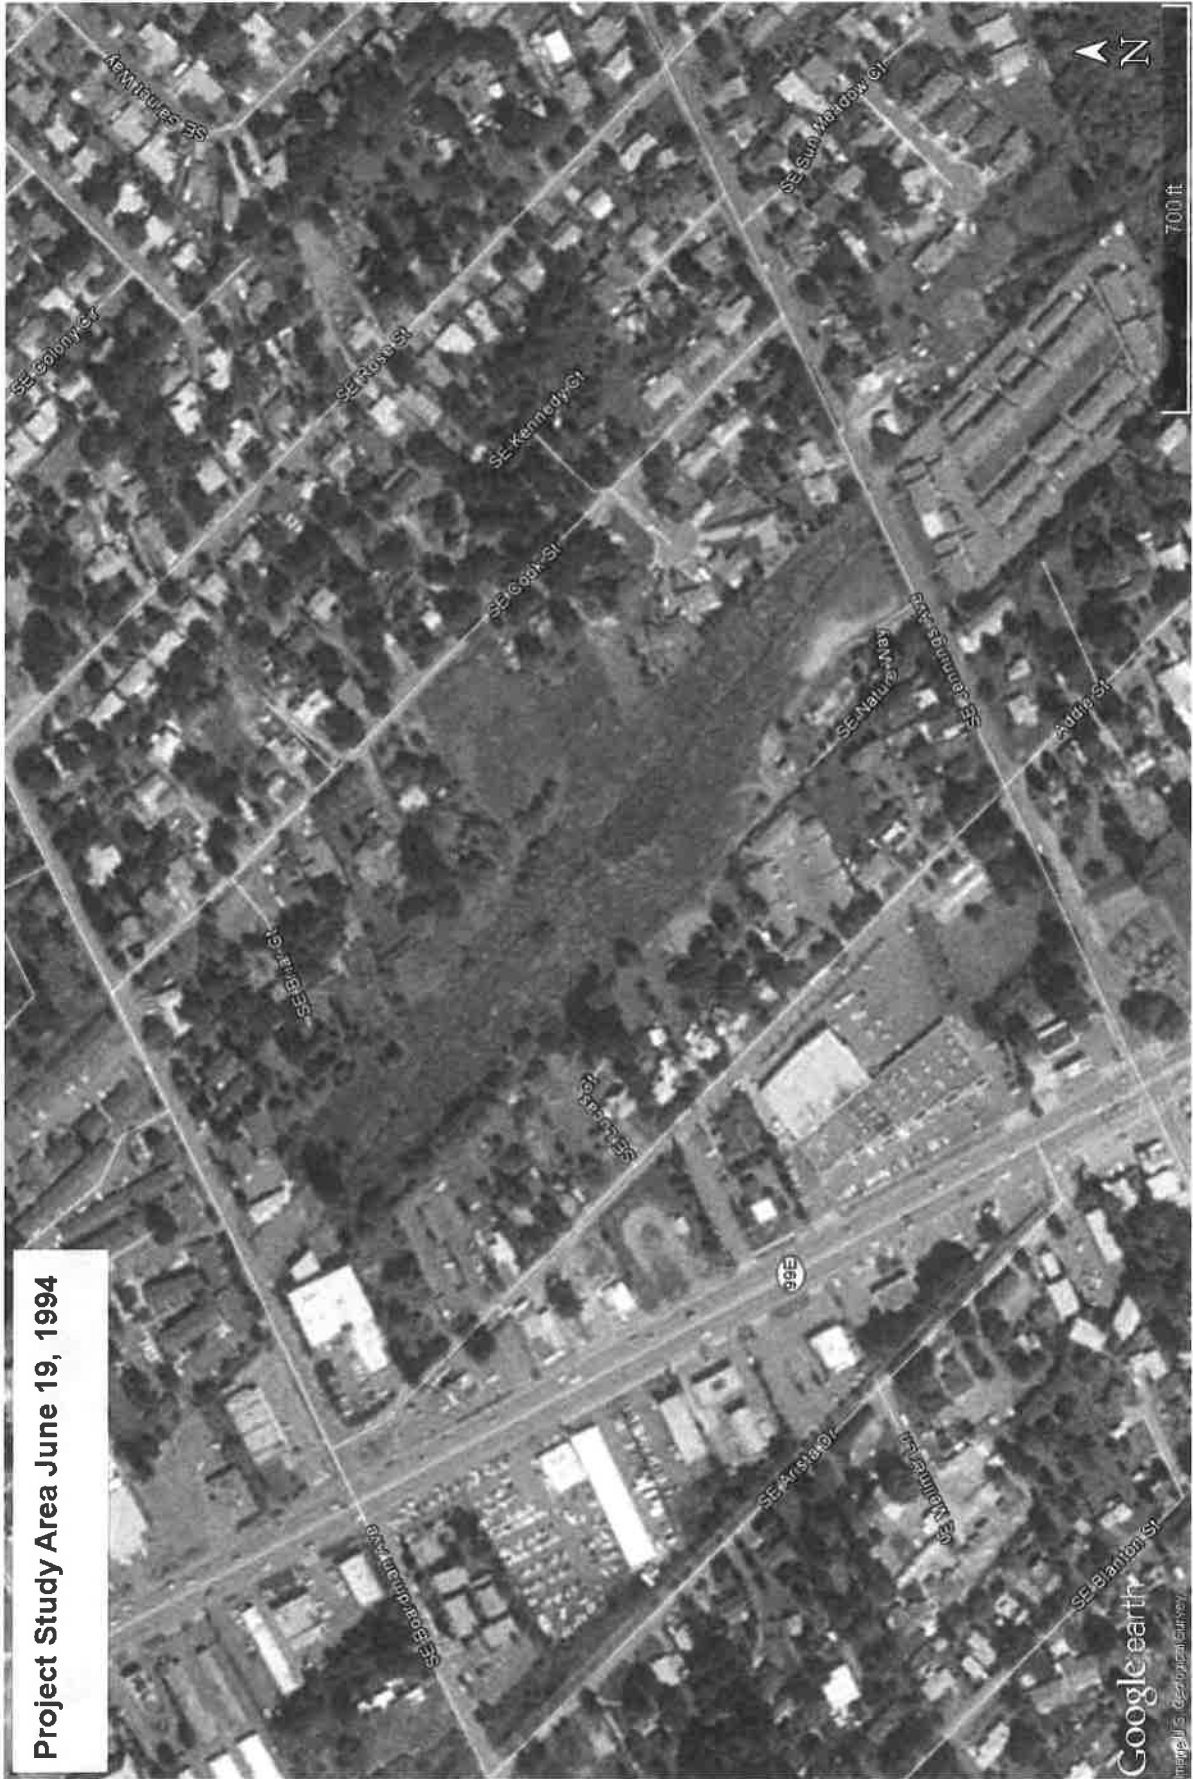
Project Study Area June 19, 1994

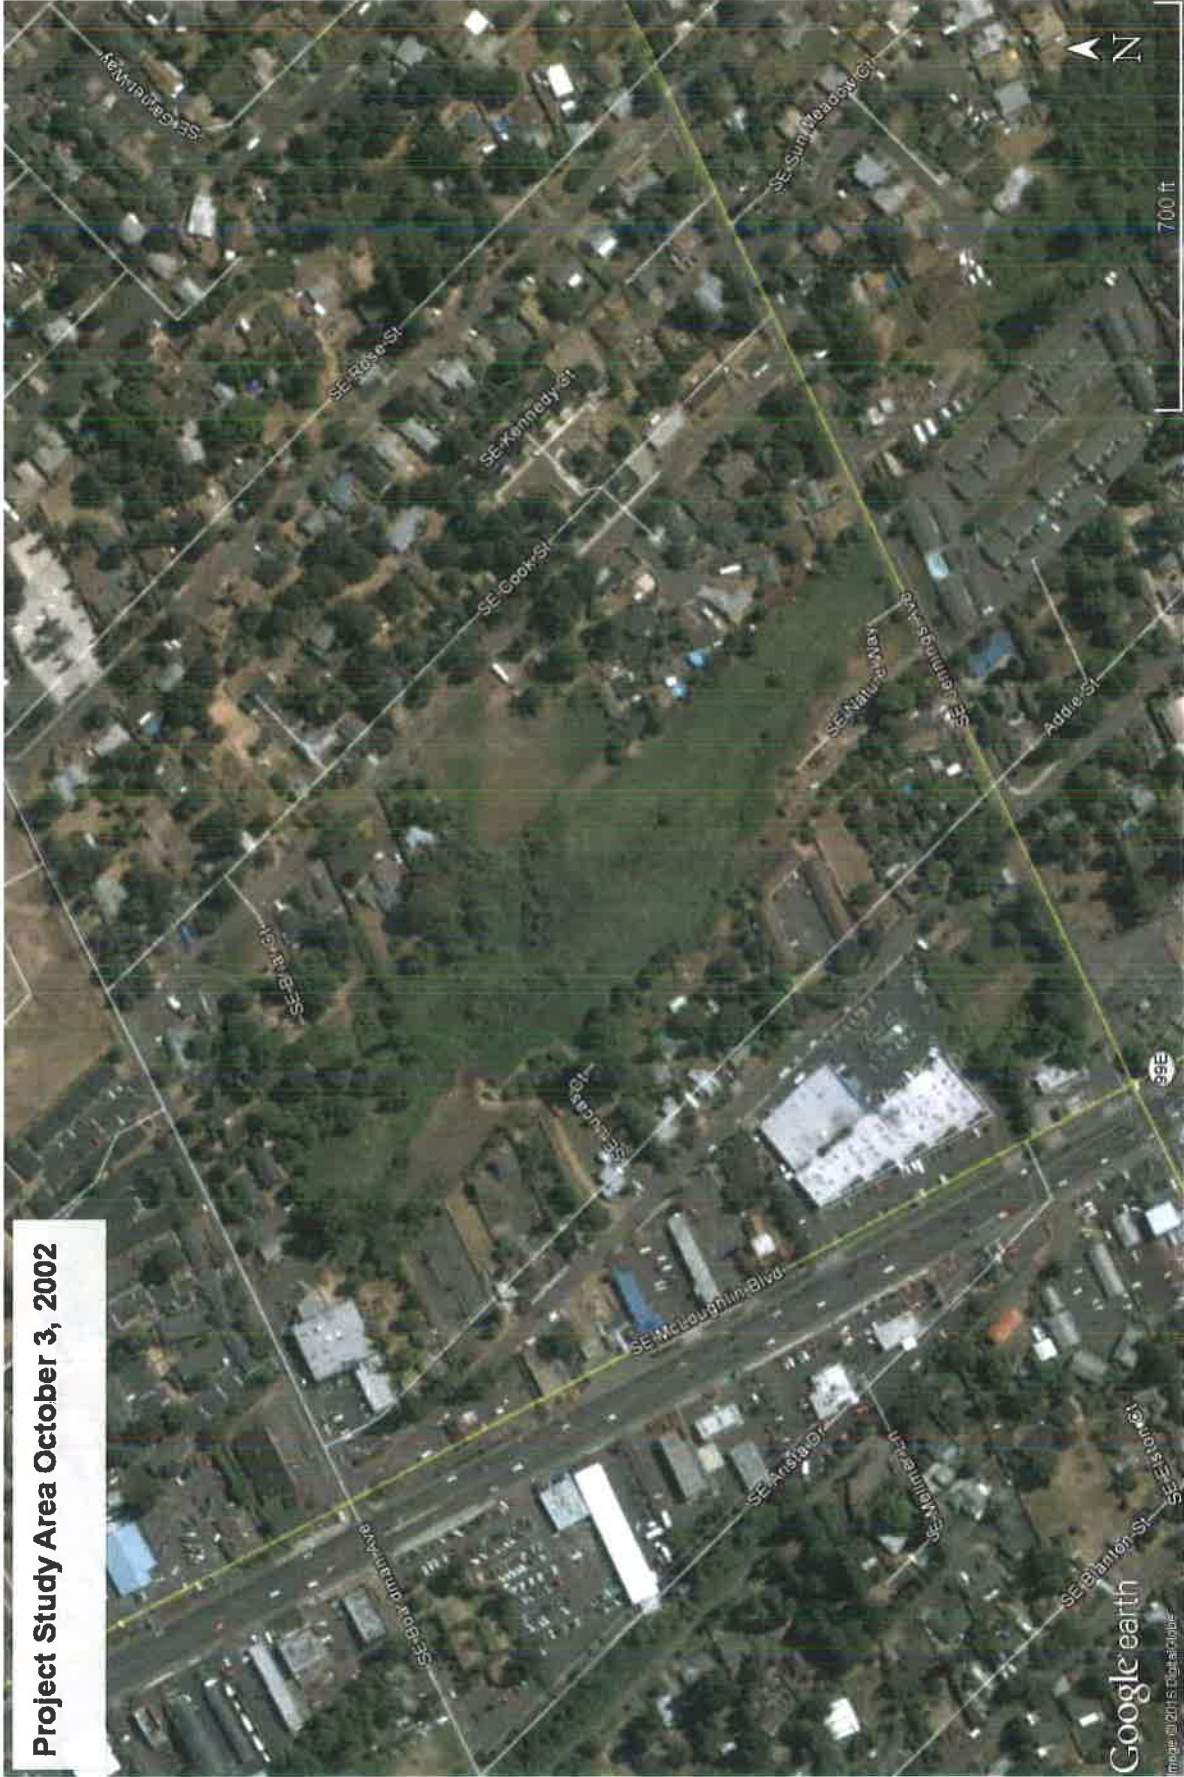
Project Study Area October 3, 2002

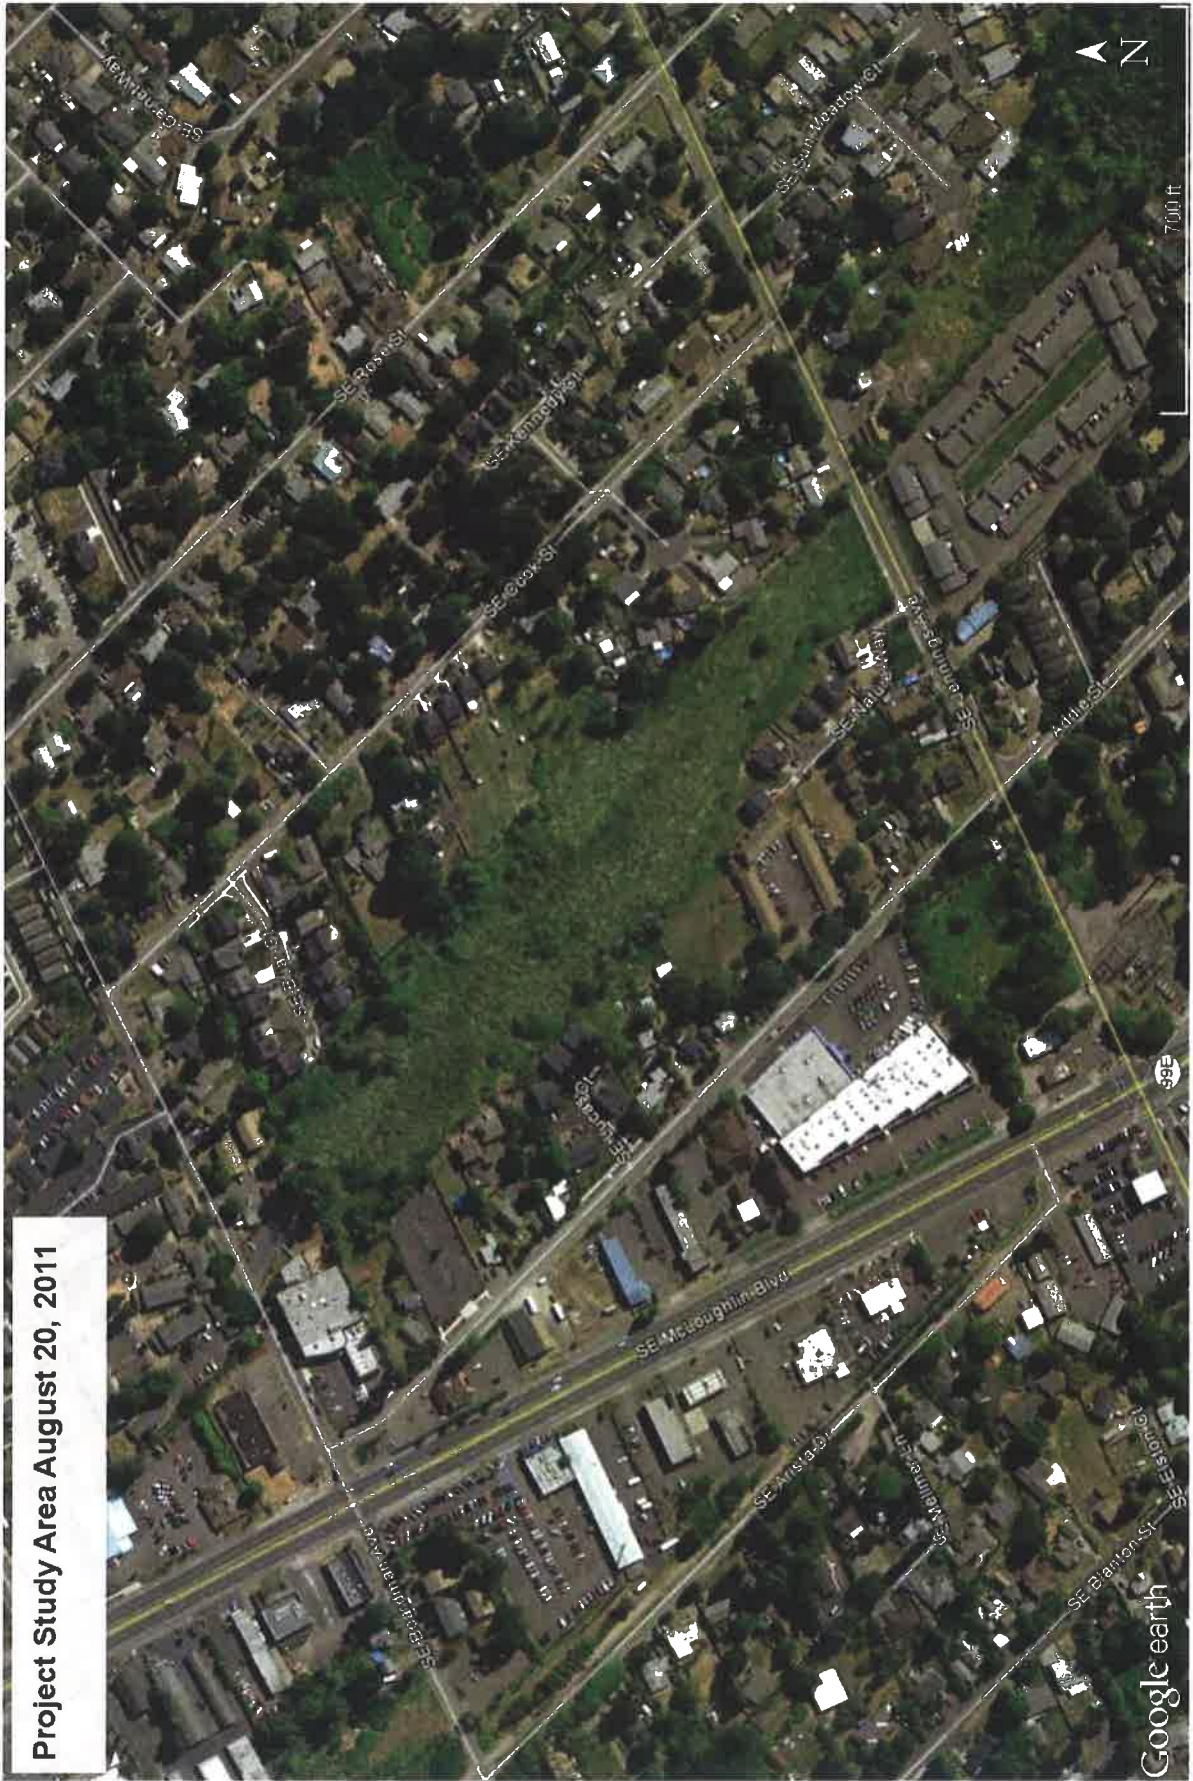
Project Study Area April 17, 2015

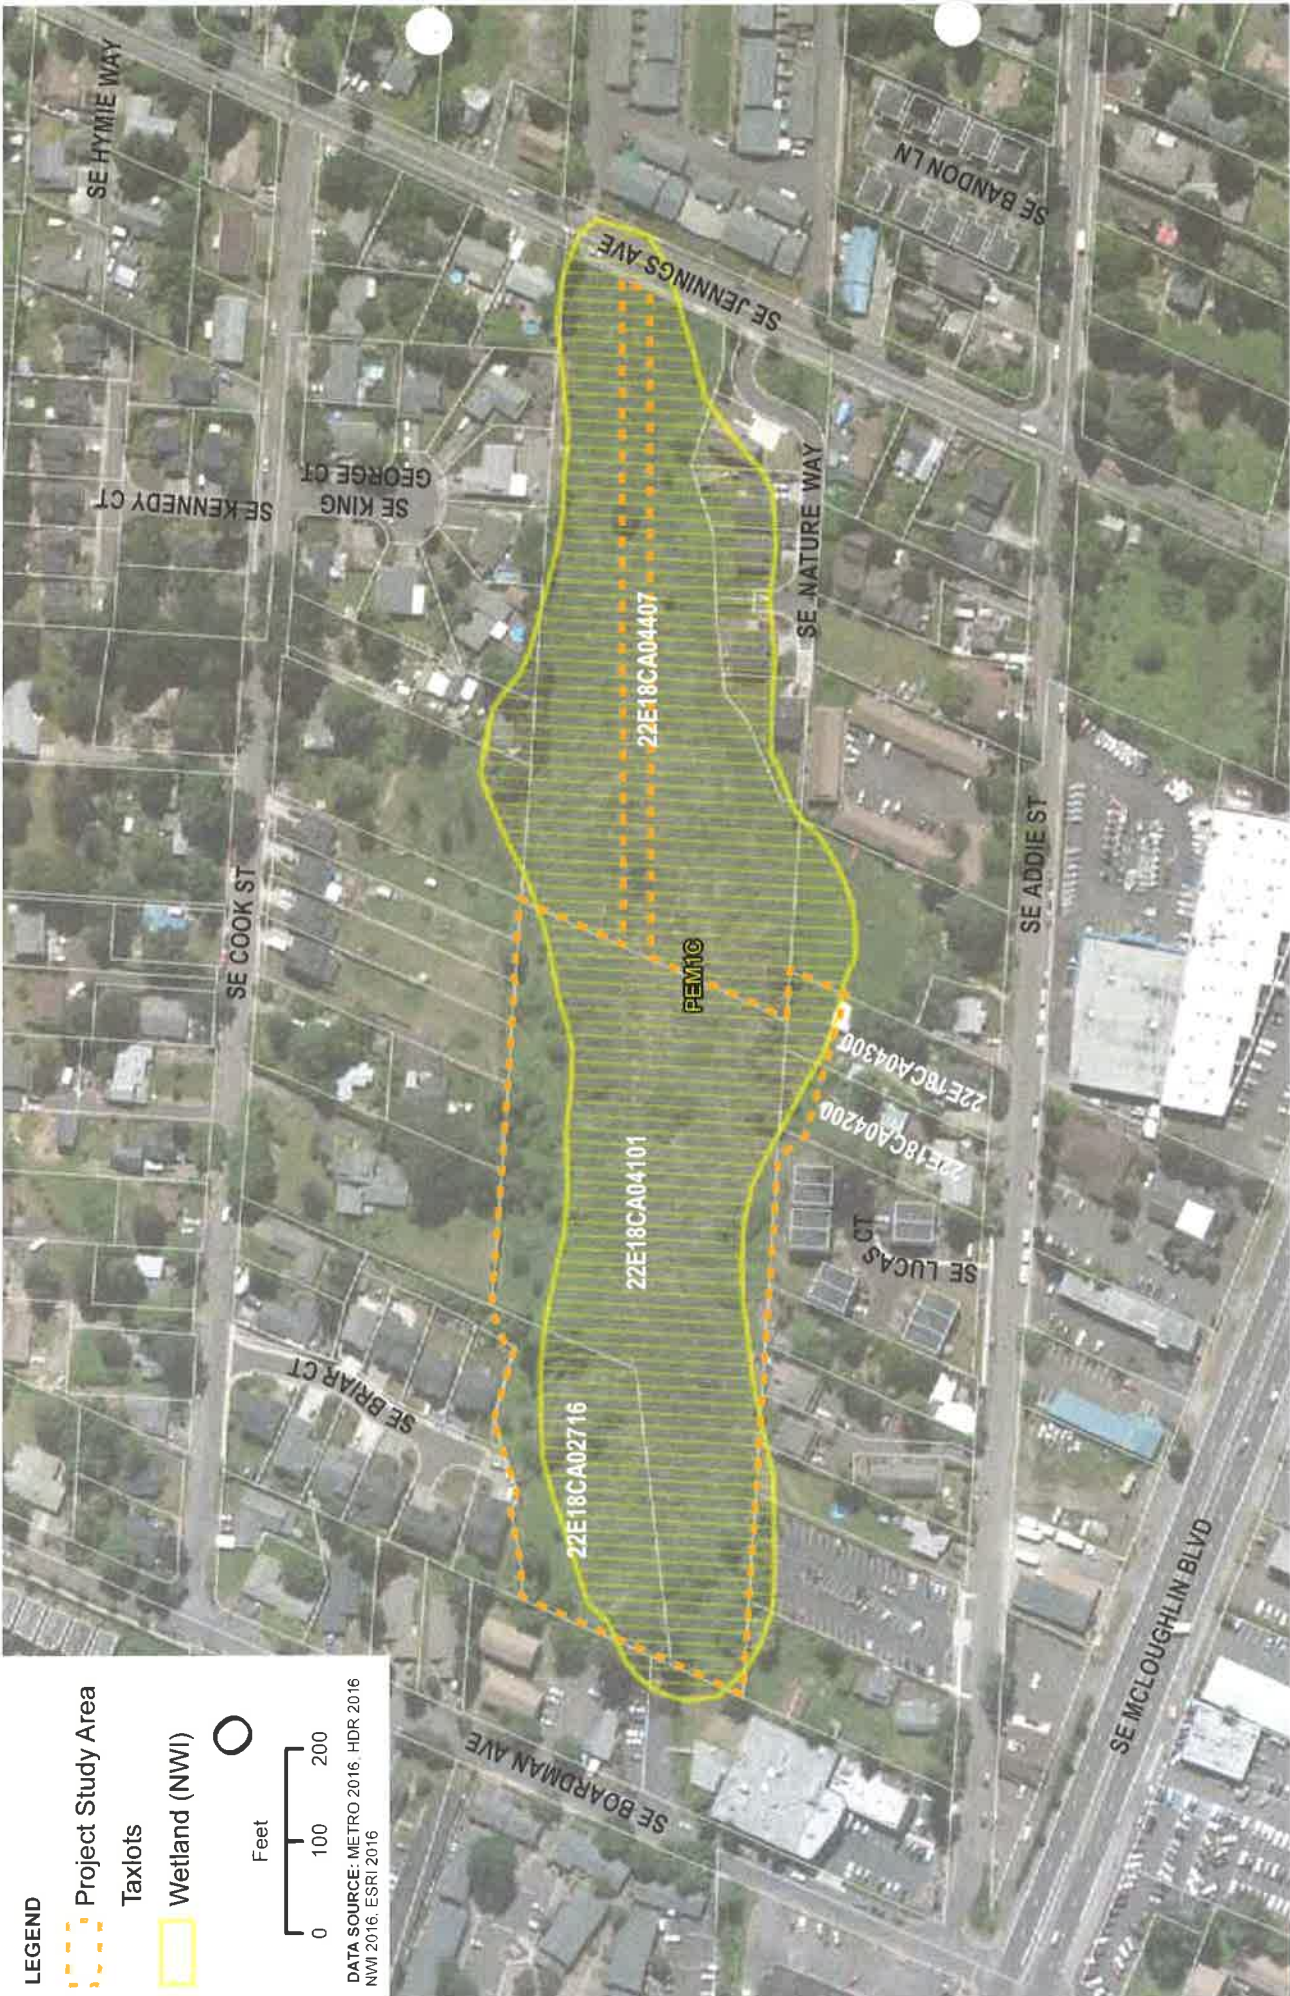
FIGURE 3

**BOARDMAN WETLAND DESIGN
NATIONAL WETLAND INVENTORY**

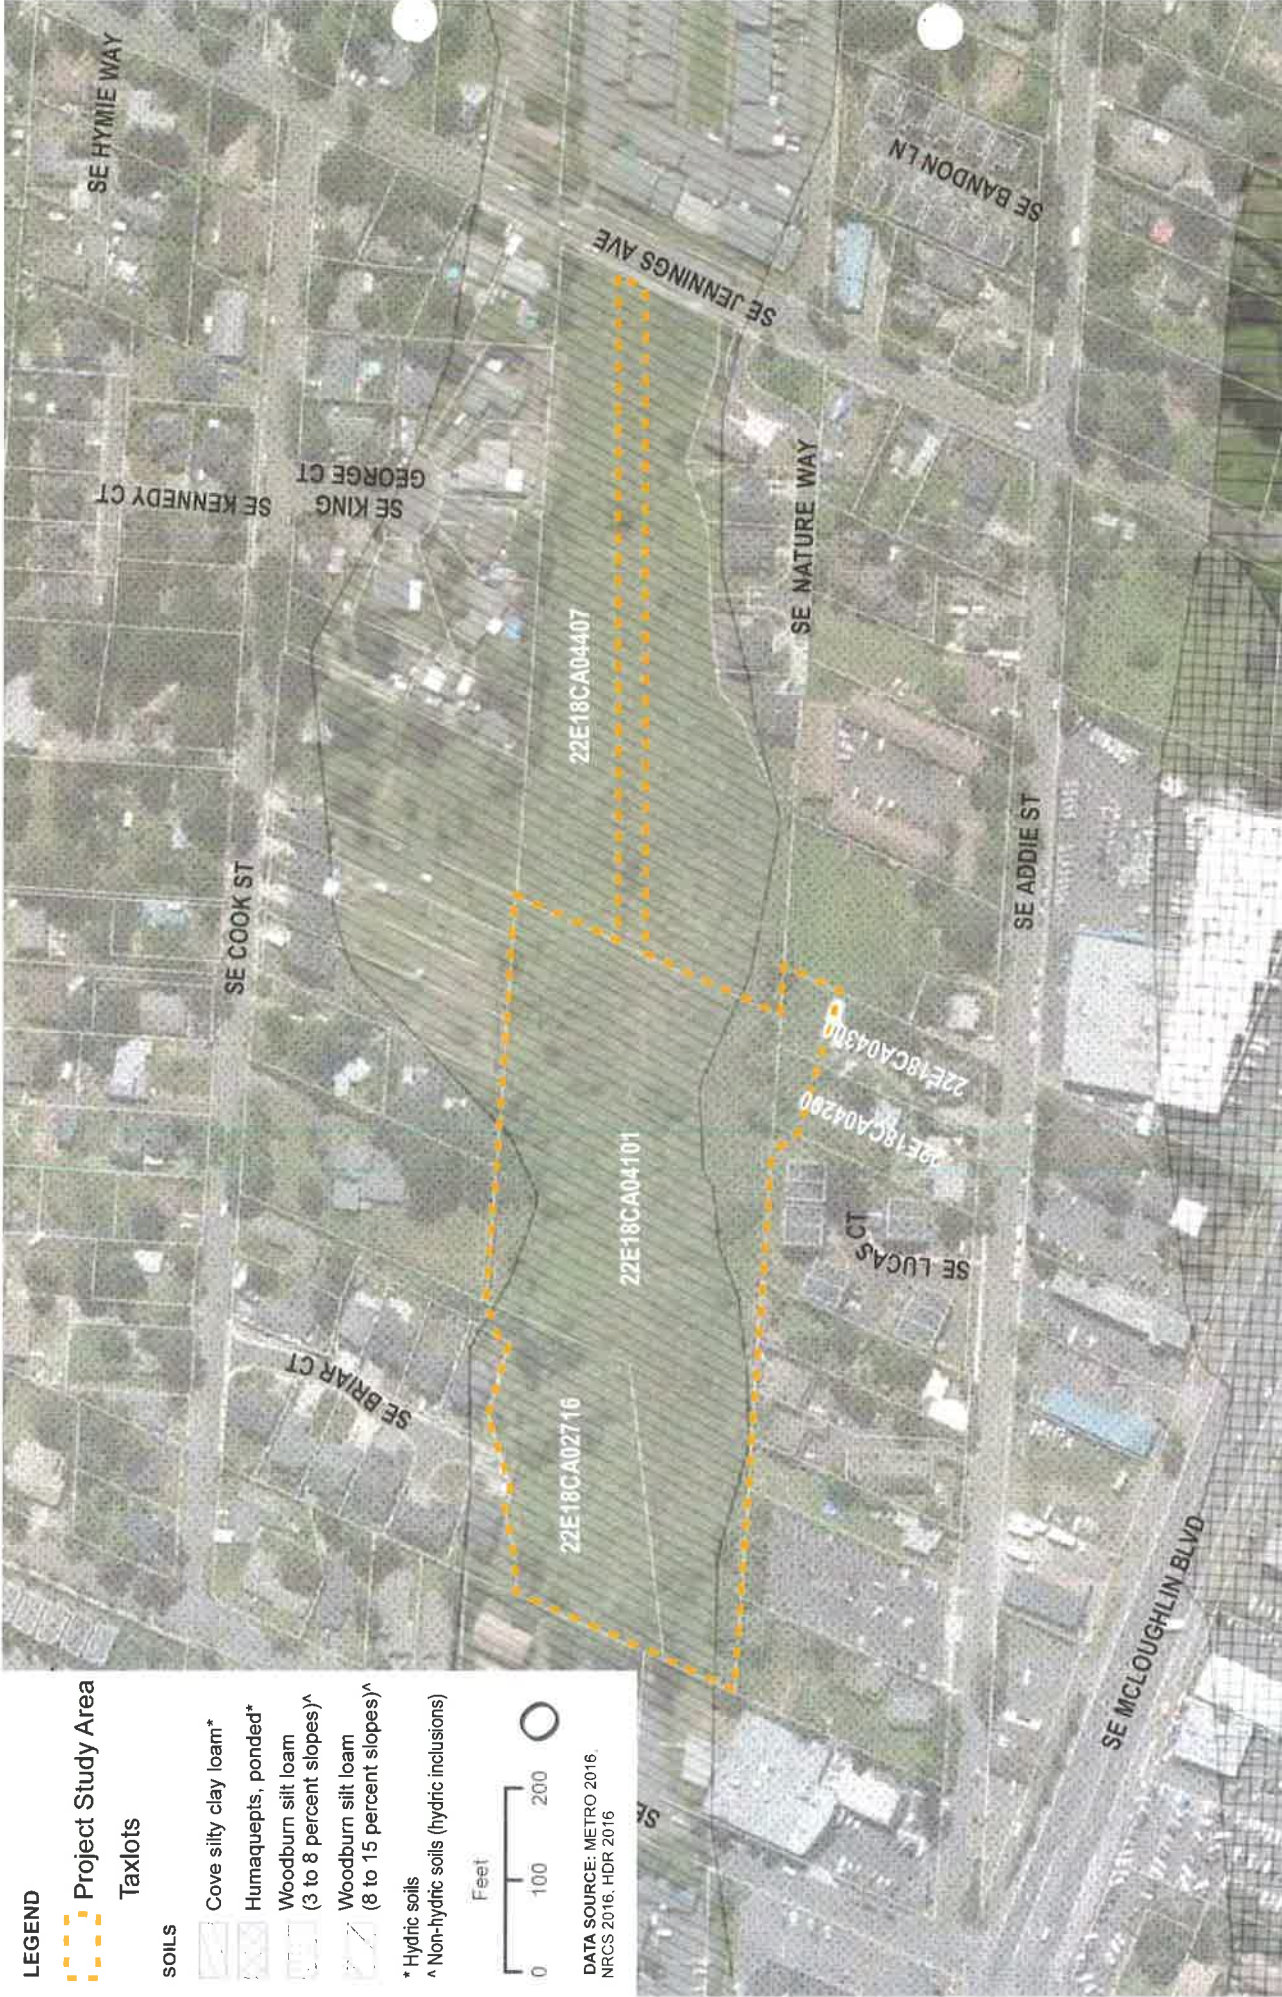
**BOARDMAN WETLAND DESIGN
MAPPED SOILS**

Soils at each representative wetland and upland sample plot were typically inspected to a depth of 15 to 26 inches to determine the presence or absence of hydric soil indicators based on the NRCS Indicators of Hydric Soils (NRCS 2010). Soil samples were moistened when necessary to aid in the determination of soil matrix and redoximorphic features (if present): hue, value, and chroma colors (Munsell Color Services, 2009). Soil texture was evaluated using field methods described by USACE and NRCS.

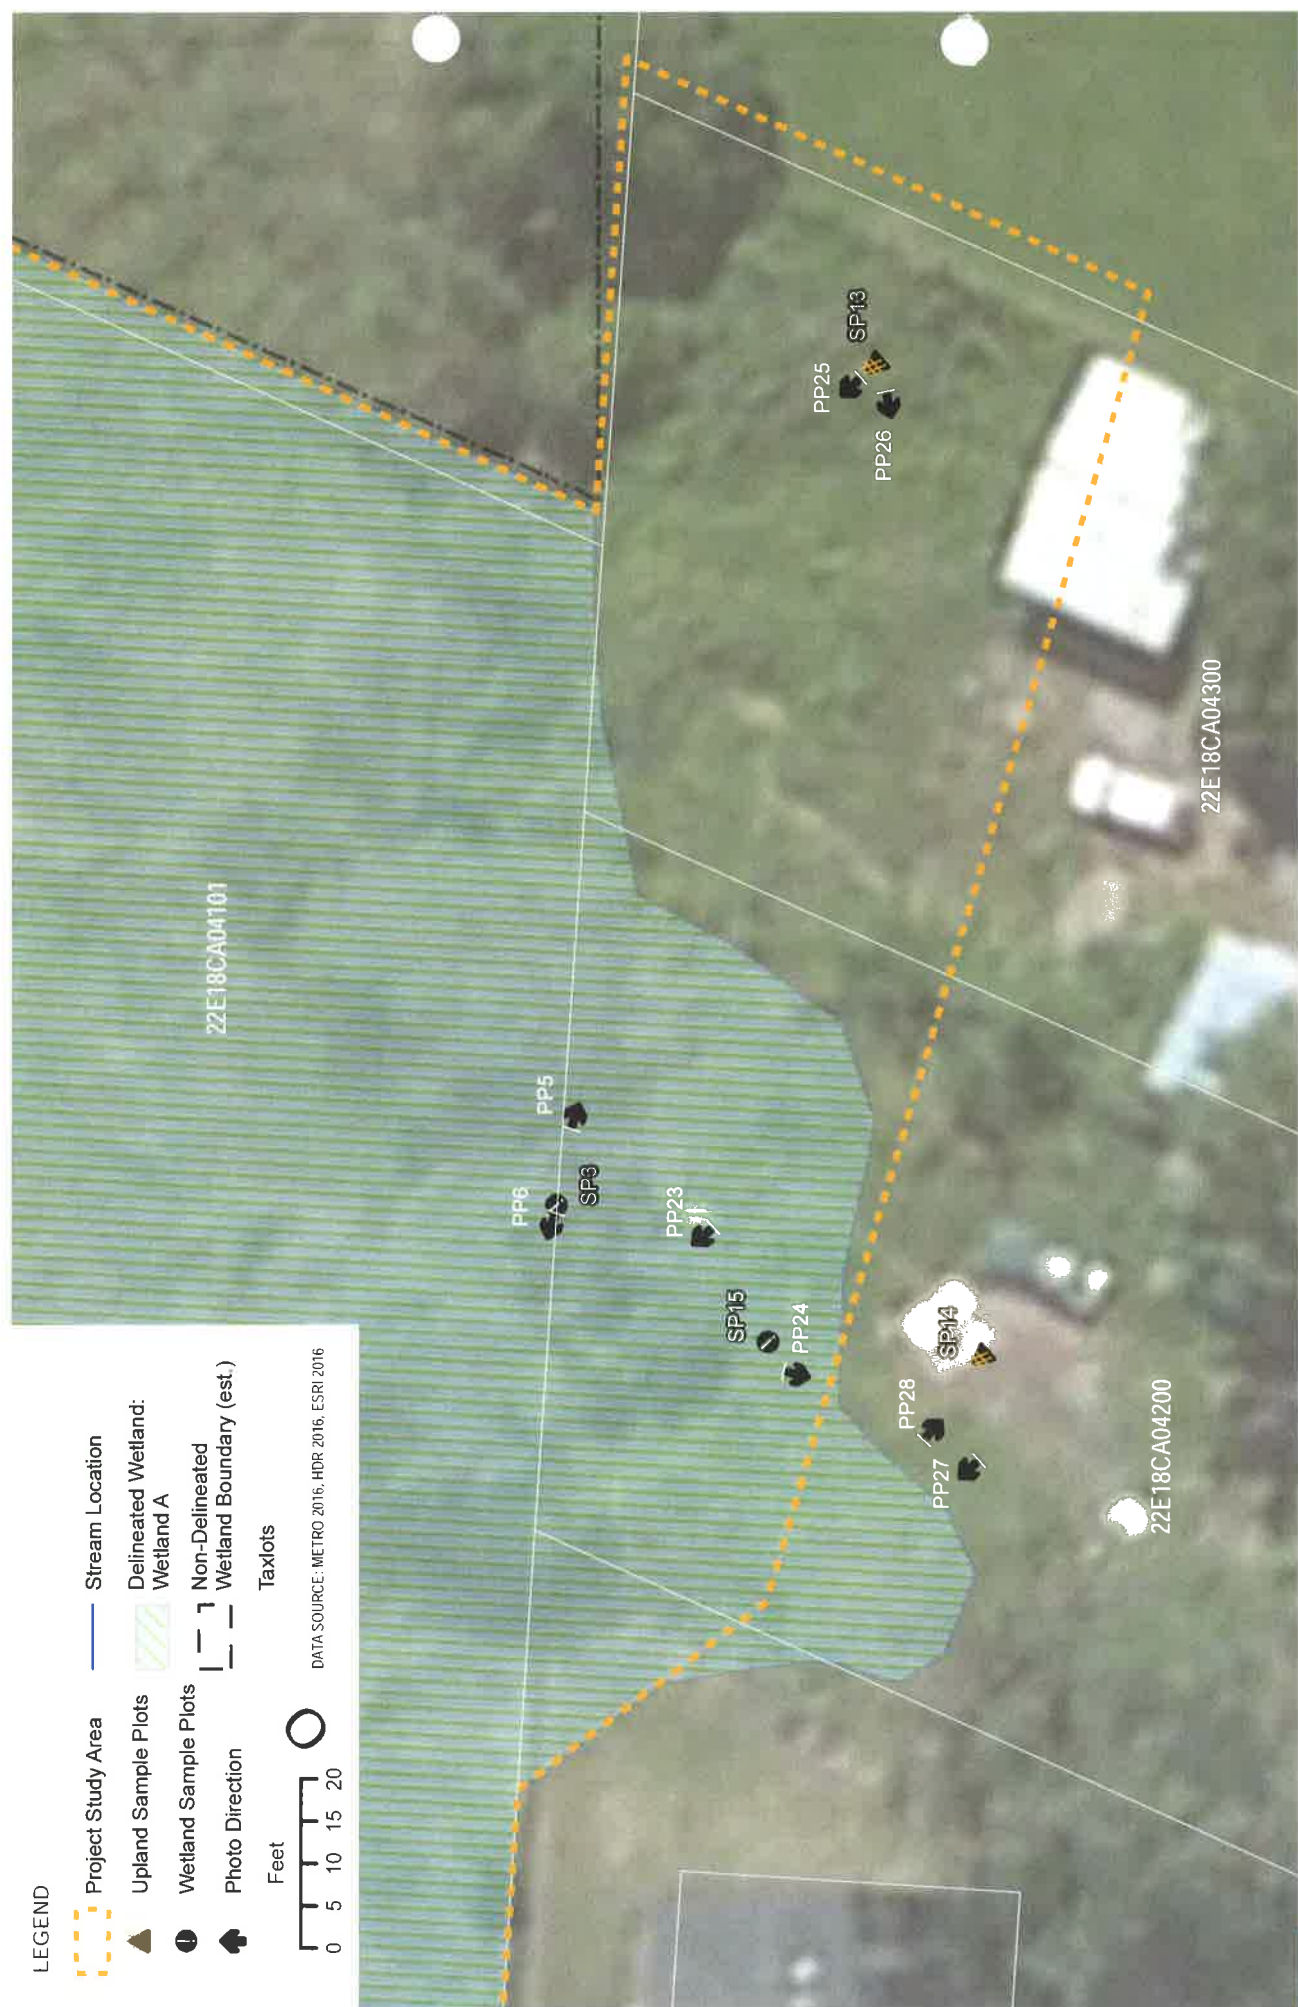
FIGURE 5E

**BOARDMAN WETLAND DESIGN
WETLAND DELINEATION**

(Appendix B). In many areas, the wetland continues offsite and no corresponding upland plot exists within the project study area. In areas highly modified by fill placement, the wetland boundary was determined by observed changes in vegetation communities and hydrological features similar to those observed at representative wetland sample plots in which data was collected. In these cases, test soil pits were dug to confirm the presence of wetland soils. Landscape elevations were reviewed on maps and in the field to aid in determining the wetland boundary in these areas.
